San Jacinto River Waste Pits Superfund Site

USACE Support

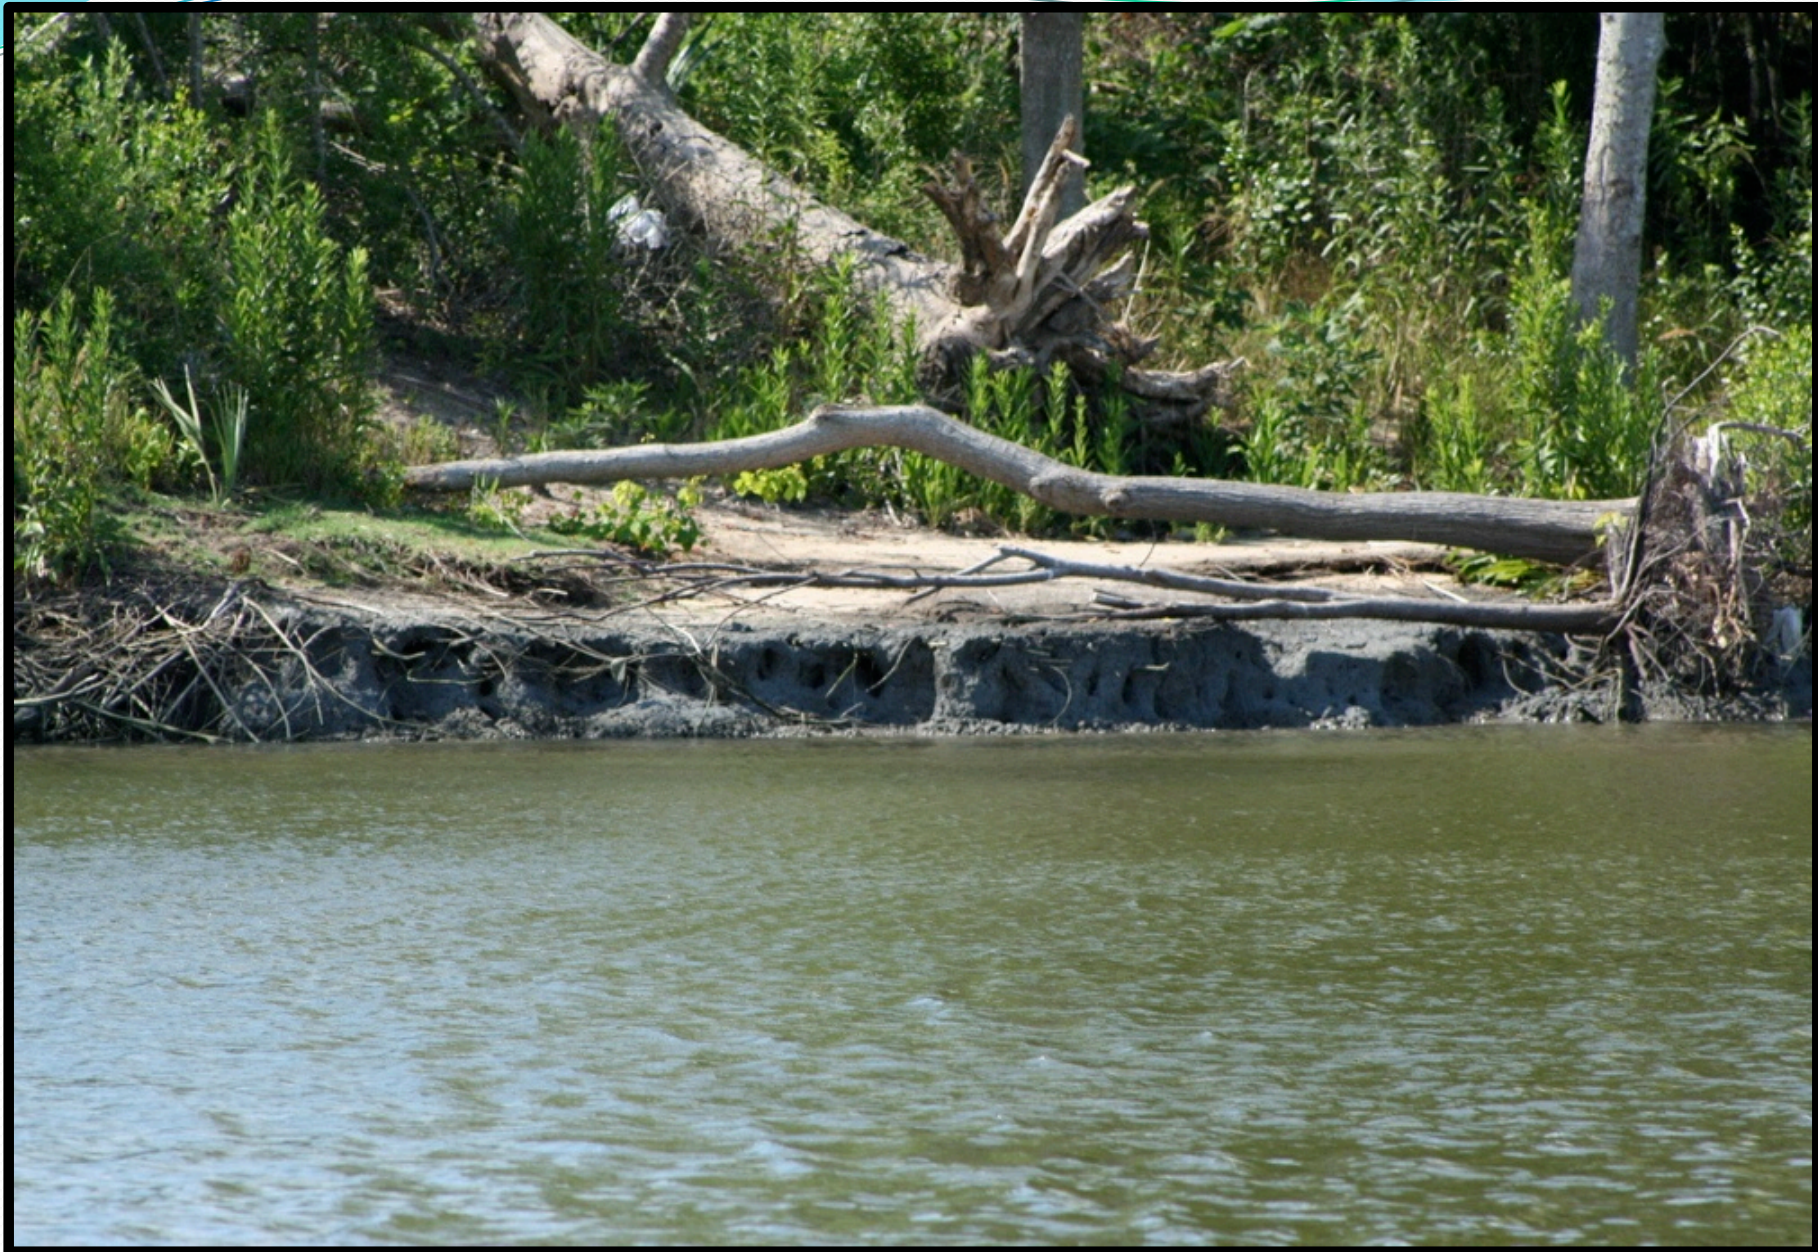
**South
Impoundment
1965**

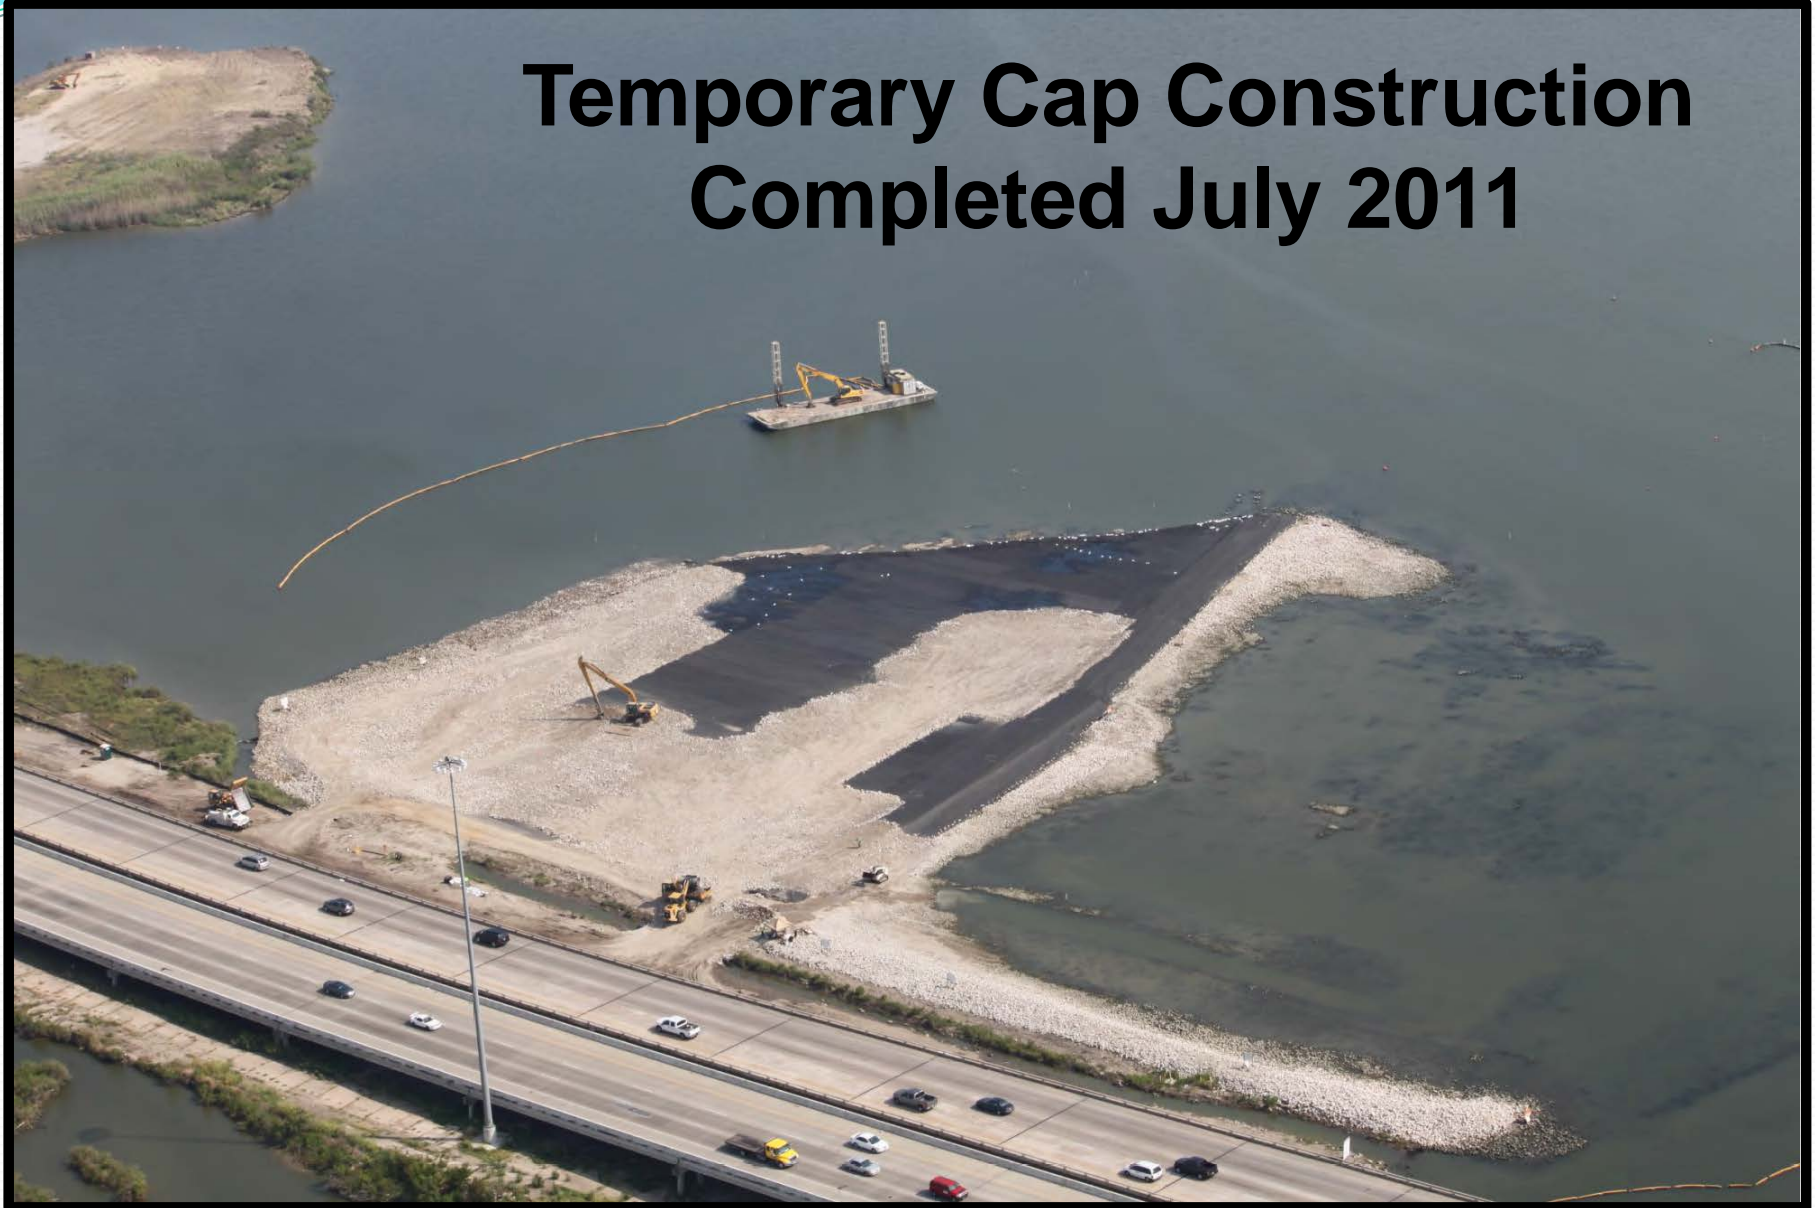
Temporary Cap Construction Completed July 2011
